Figure C-2
1954 IMAGERY
Stream Improvement Plan
Tongue River
Sheridan County
Conservation District
Dayton, Wyoming

PARCEL BOUNDARIES
 Tongue River Stream Improvement Plan
 Sheridan County Conservation District
 Dayton, Wyoming

LATERAL EROSION RATES
Tongue River Stream Improvement Plan
Sheridan County Conservation District
Dayton, Wyoming

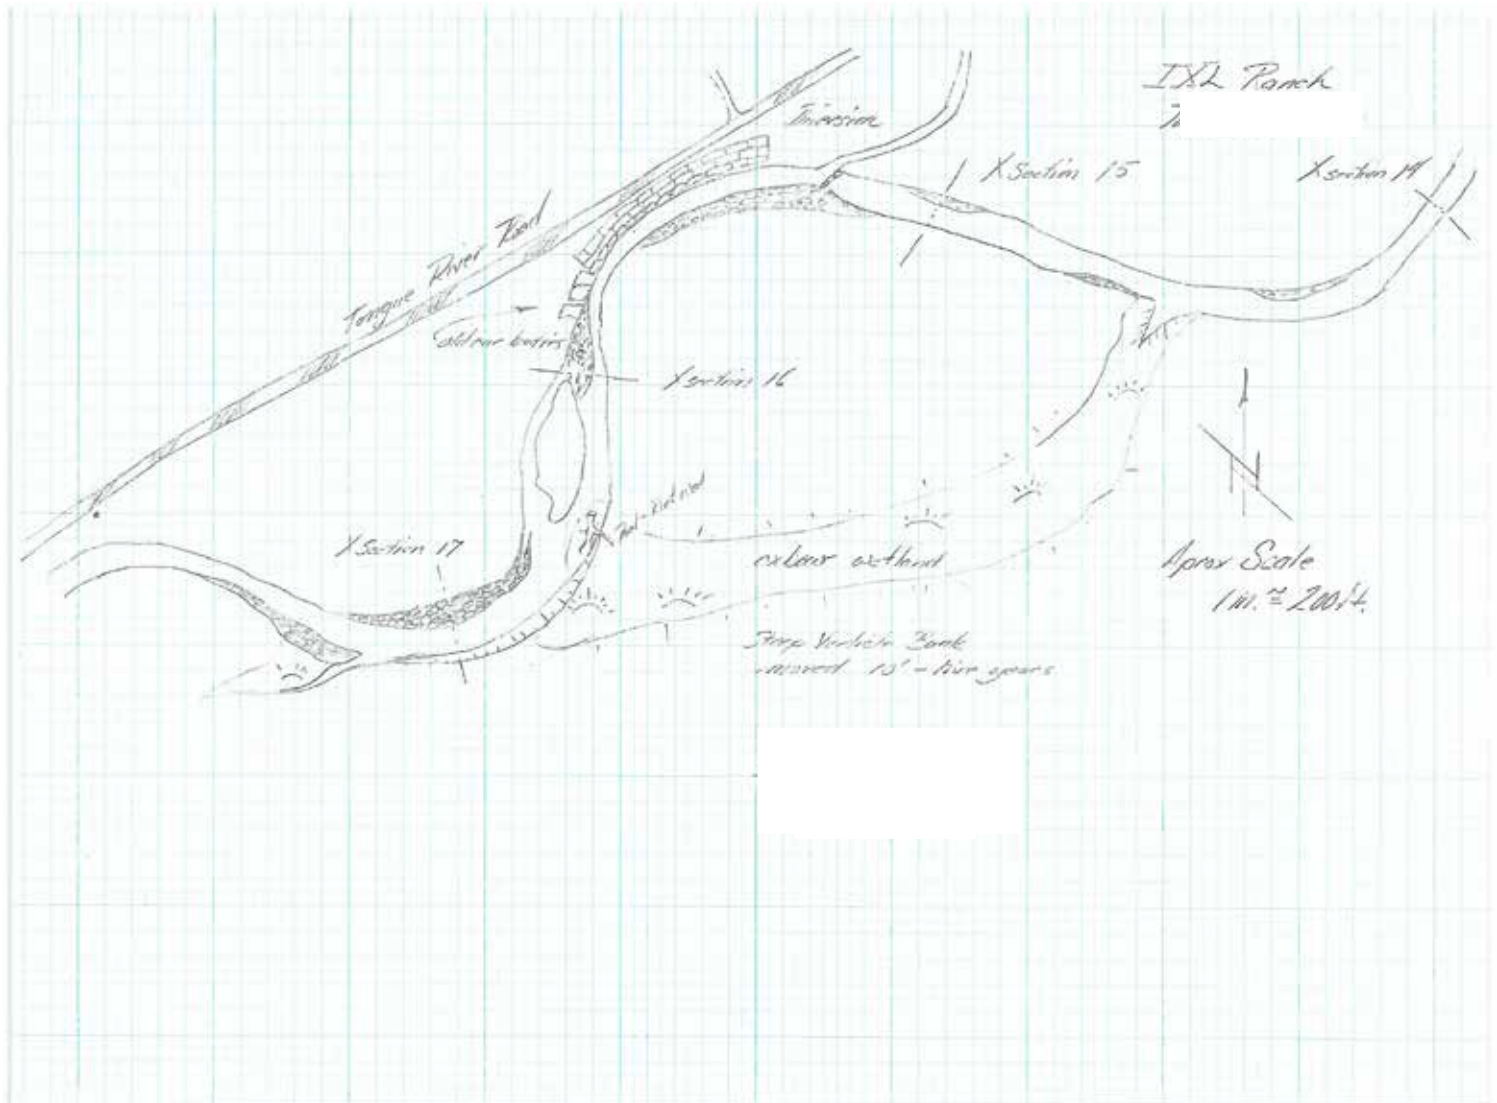
Site Diagram

- Element 1: Channel Elevation Model stage III. Active lateral movement.
- Element 4: Riparian Area Quantity. Active bank erosion has removed many of the woody elements through this reach which also affects the canopy cover. Fire in 2003 has removed much of the older vegetation and caused bank instability. The river lacks enough power to move the bed load through this reach due to high width to depth ratio and perhaps by removal of flood water for irrigation.
- Element 5: Riparian Area Quality. The native wetland vegetation has been left high and dry by lowered water table.
- Element 6: The Canopy Cover is lacks the shrub element and overhanging vegetation again to the fire of 03.
- Element 10. Pools this reach however seldom encountered are a primary result of scour from remnant woody material washed into the stream resulting from the fire.

1. Stabilize eroding stream banks either by allowing the river to adjust its length or construct structures. Create riffle pool complexes with the structures. Landowners may use structures downstream as a blueprint for future work on this reach.
2. There is a general lack of woody material in this reach. Consider pine tree revetment, root wade or toe wood installations Add structure to channel at strategic locations to create riffle/pool complexes. Plant trees and shrubs along bank to shade the waterway.
3. Define intermediate berm during low water periods and use the meander pattern in place to enhance pattern.
4. Replace push up diversion with a permanent one that allows for fish passage, keeps fish out of the irrigation ditch and allows the river to pass the bed load.

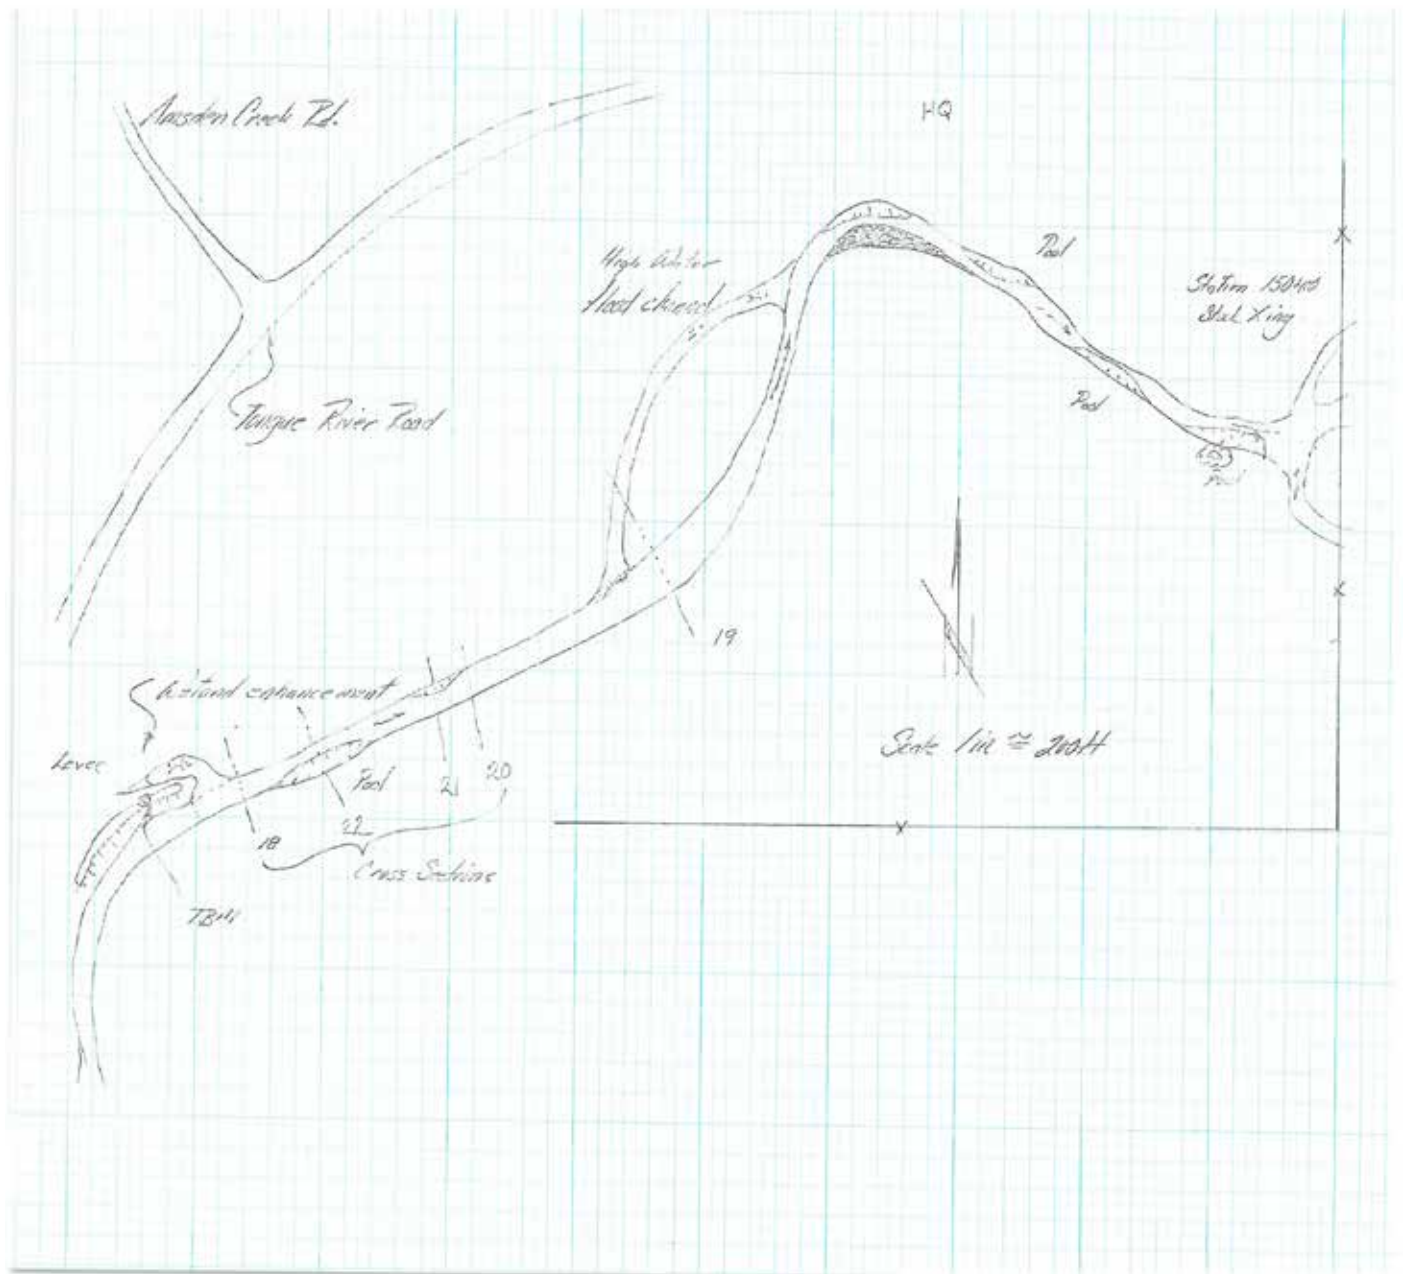
Site Diagram

- Element 1: Channel Elevation Model stage III. Active lateral movement.
- Element 4: Riparian Area Quantity. Active bank erosion has removed many of the woody elements through this reach which also affects the canopy cover. Fire in 2003 has removed much of the older vegetation and caused bank instability. The river lacks enough power to move the bed load through this reach due to high width to depth ratio and perhaps by removal of flood water for irrigation.
- Element 5: Riparian Area Quality. The native wetland vegetation has been left high and dry by lowered water table.
- Element 6: The Canopy Cover is lacks the shrub element and overhanging vegetation again to the fire of 03.
- Element 10. Pools this reach however seldom encountered are a primary result of scour from remnant woody material washed into the stream resulting from the fire.

1. Stabilize eroding stream banks ether by allowing the river to adjust its length or construct structures. Create riffle pool complexes with the structures. Landowners may use structures downstream as a blueprint for future work on this reach.
2. There is a general lack of woody material in this reach. Consider pine tree revetment, root wade or toe wood installations Add structure to channel at strategic locations to create riffle/pool complexes. Plant trees and shrubs along bank to shade the waterway.
3. Define intermediate berm during low water periods and use the meander pattern in place to enhance pattern.
4. Replace push up diversion with a permanent one that allows for fish passage, keeps fish out of the irrigation ditch and allows the river to pass the bed load.

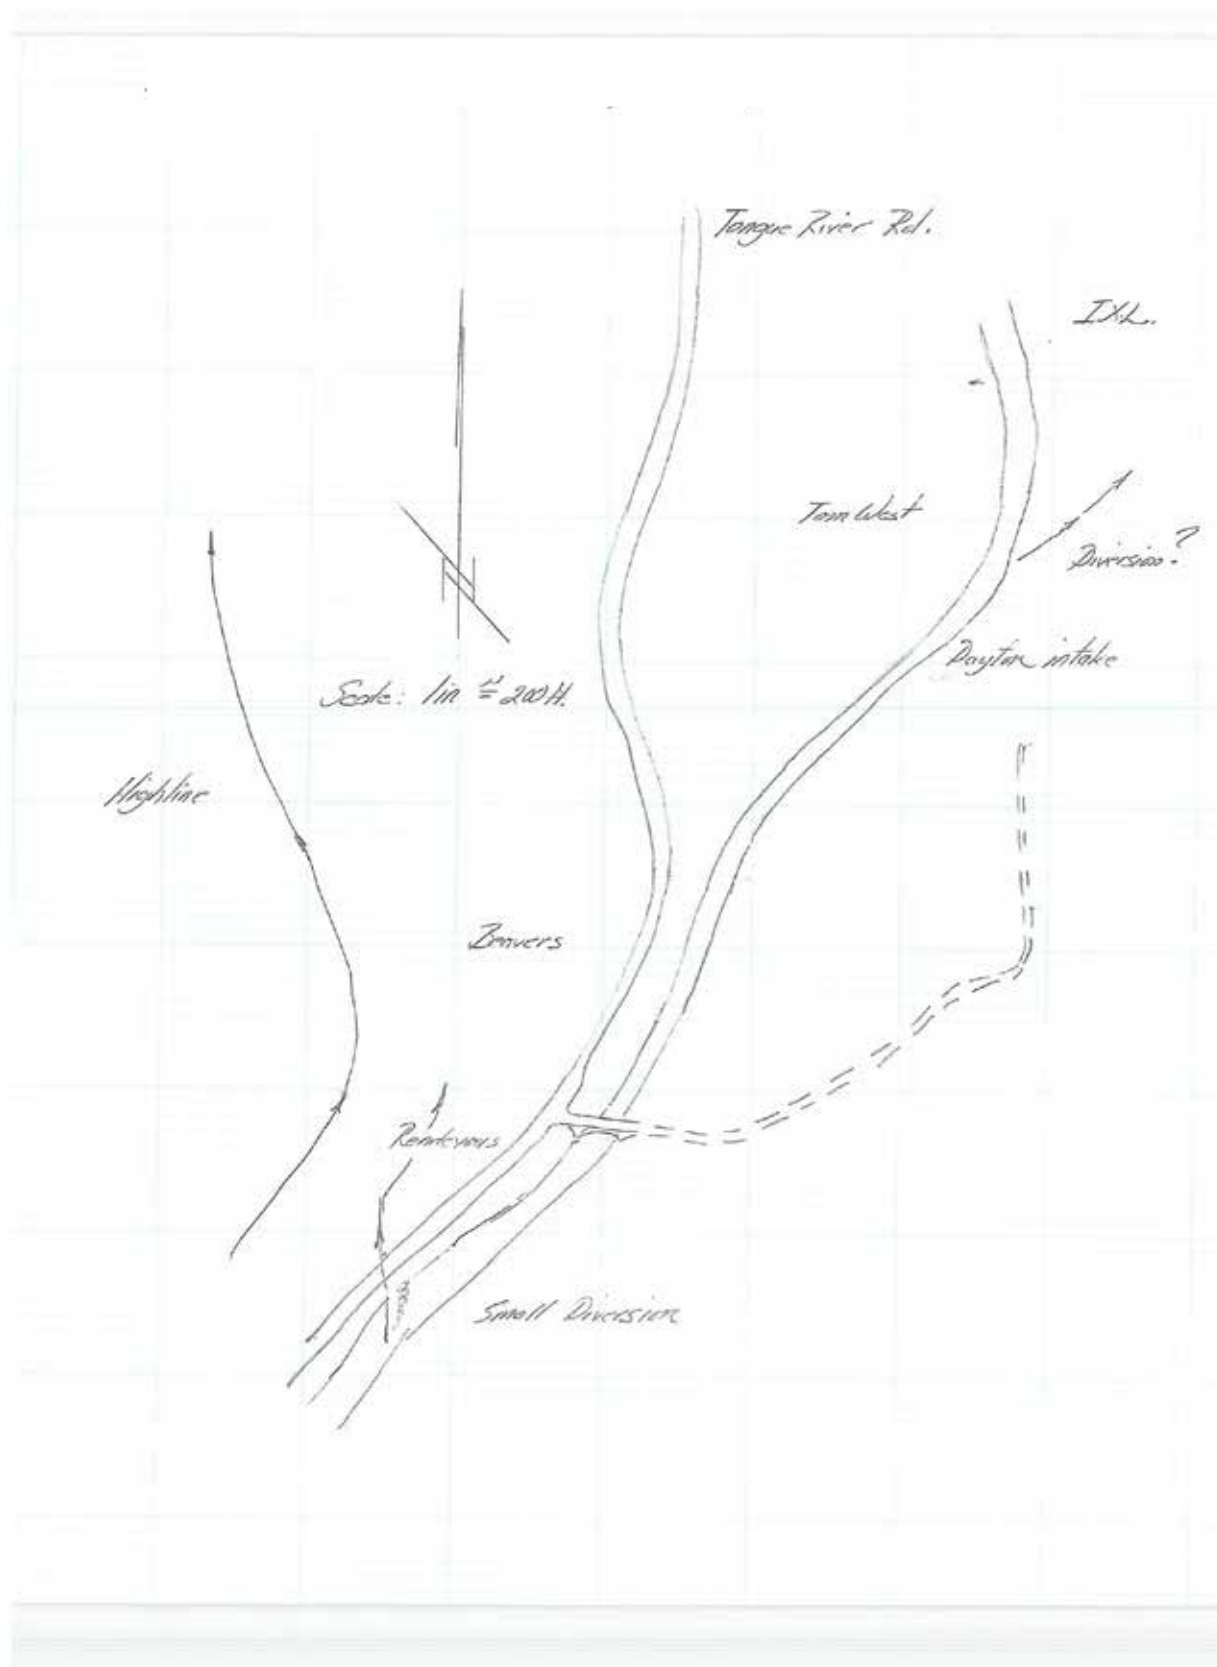
Site Diagram

- Element 1: Channel Condition appears to be aggrading. One mid channel bar has formed at about 101+00 and is over wide.
- Element 4: Riparian Area Quantity.
- The river appears to lack enough power to move the bed load through this reach due to high width to depth ratio and perhaps by removal of flood water for irrigation and or change in slope.
- Element 6: The Canopy Cover is lacking the shrub element and overhanging vegetation.
- Element 10. Deep pools (two to three times mean depth) not found. Most pools are a primary result of woody material washed into the stream.

- Consider abandoning small diversion and utilizing the highline ditch. The elevation difference between the irrigated land and the water surface in the ditch could allow for a gravity sprinkler conversion from flood. More water efficient and more productive.
- Define the correct pattern for this reach in terms of width to depth ratio.

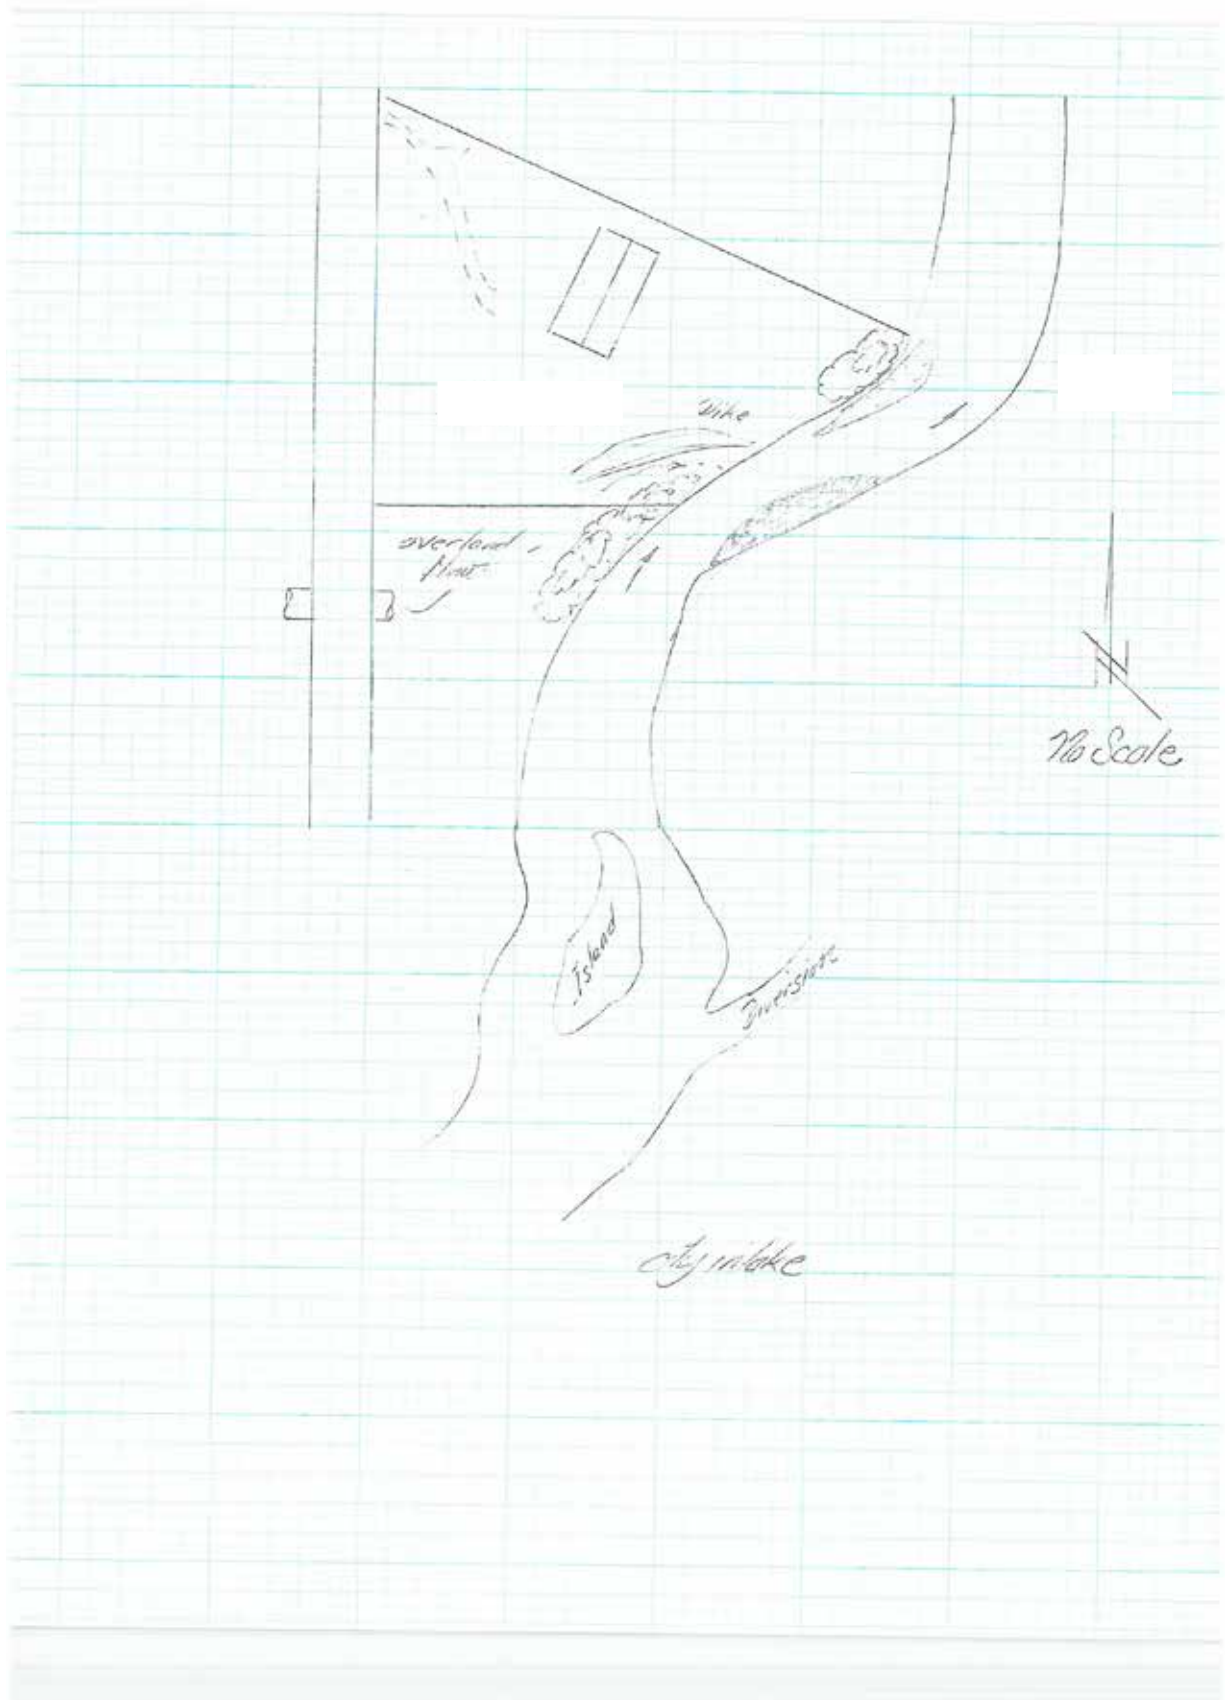
Site Diagram

- Element 1: Channel Condition Evolution Model stage III. Active lateral movement.
- Element 4: Riparian Area Quantity. Active bank erosion and land use changes has removed many of the woody elements through this reach which also affects the canopy cover.
- Element 5: Riparian Area Quality has converted riparian woody vegetation with lawn species. The river lacks enough power to move the bed load through this reach due to high width to depth ratio and perhaps by removal of flood water for irrigation and or change in slope.
- Element 6: The Canopy Cover is lacks the shrub element and overhanging vegetation.
- Element 10. Pools are few and relatively.

1. Replace erosion resistant vegetation with structures either wood, rock, or herbaceous low growing buffer.
2. Consider pine tree revetment, root wade or toe wood installations.
3. Define the Correct pattern for this reach in terms of width to depth ration.
4. Protect property from overland flow from uplands with dike.

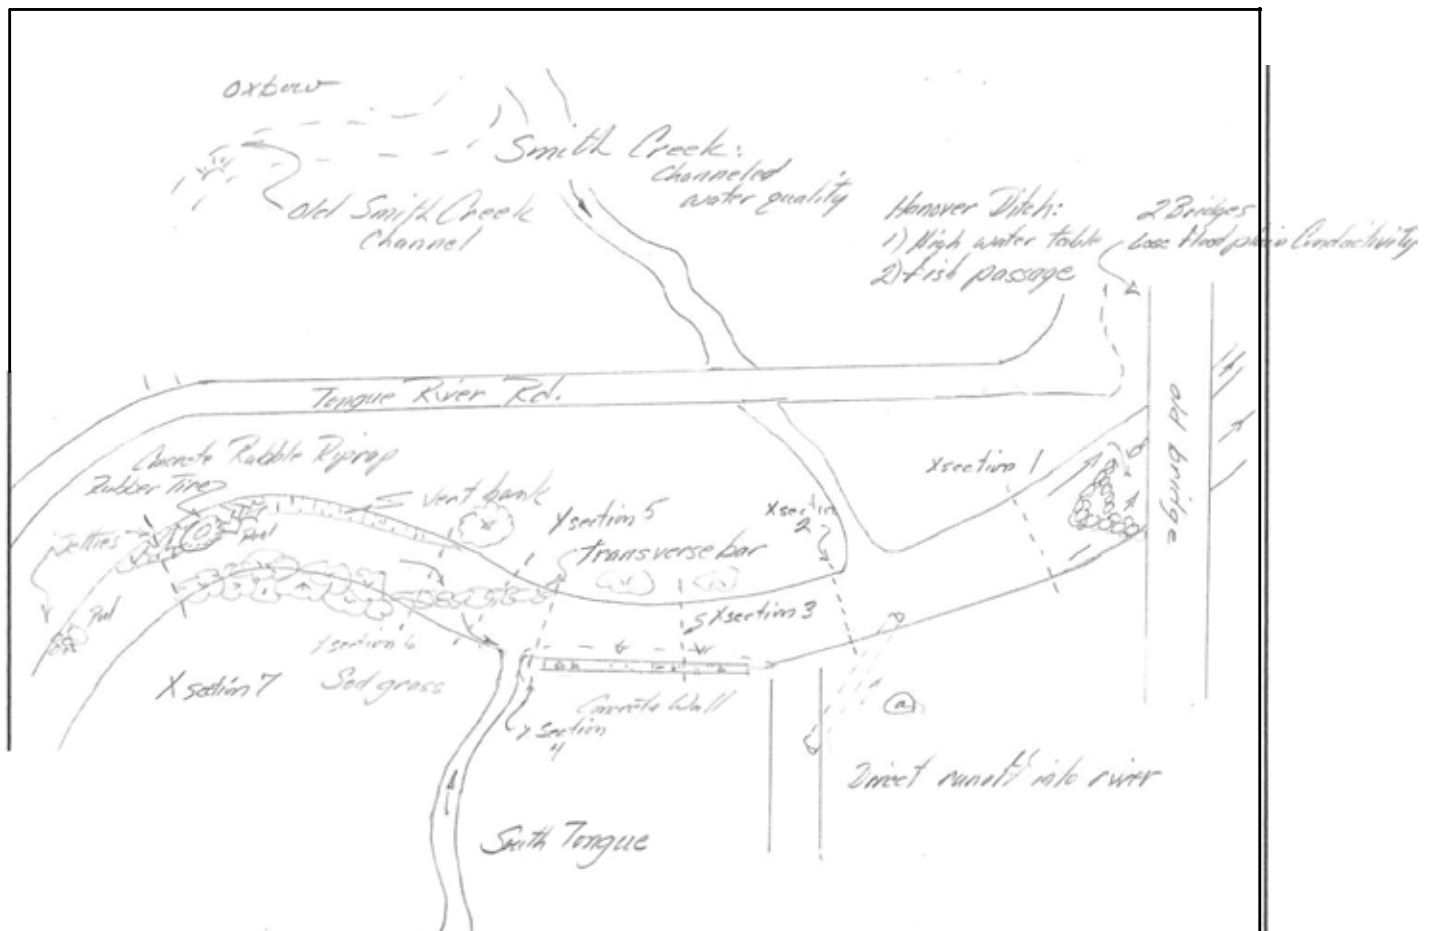
Site Diagram

- Element 1: The Channel is trying to adjust its width. The top of bars are below the active flood plain.
- Element 3: Bank erosion high to very high. Stabilization structures covering 1/3 of reach. A Transverse bar is forming at X section 6.
- Element 4: Riparian Area Quantity. The River is incised through this reach which limits the width of the riparian area. Vegetation gaps are about 50% of the total length.
- Element 5: Riparian Area Quality. The native wetland vegetation has been replaced in many areas of this reach with sod forming grasses for lawns. Invasive species like Russian olive and Reed Canary grass have replaced them. Over half the outside meanders aren't adequately buffered.
- Element 6: The Canopy Cover lacks the shrub element and overhanging vegetation.

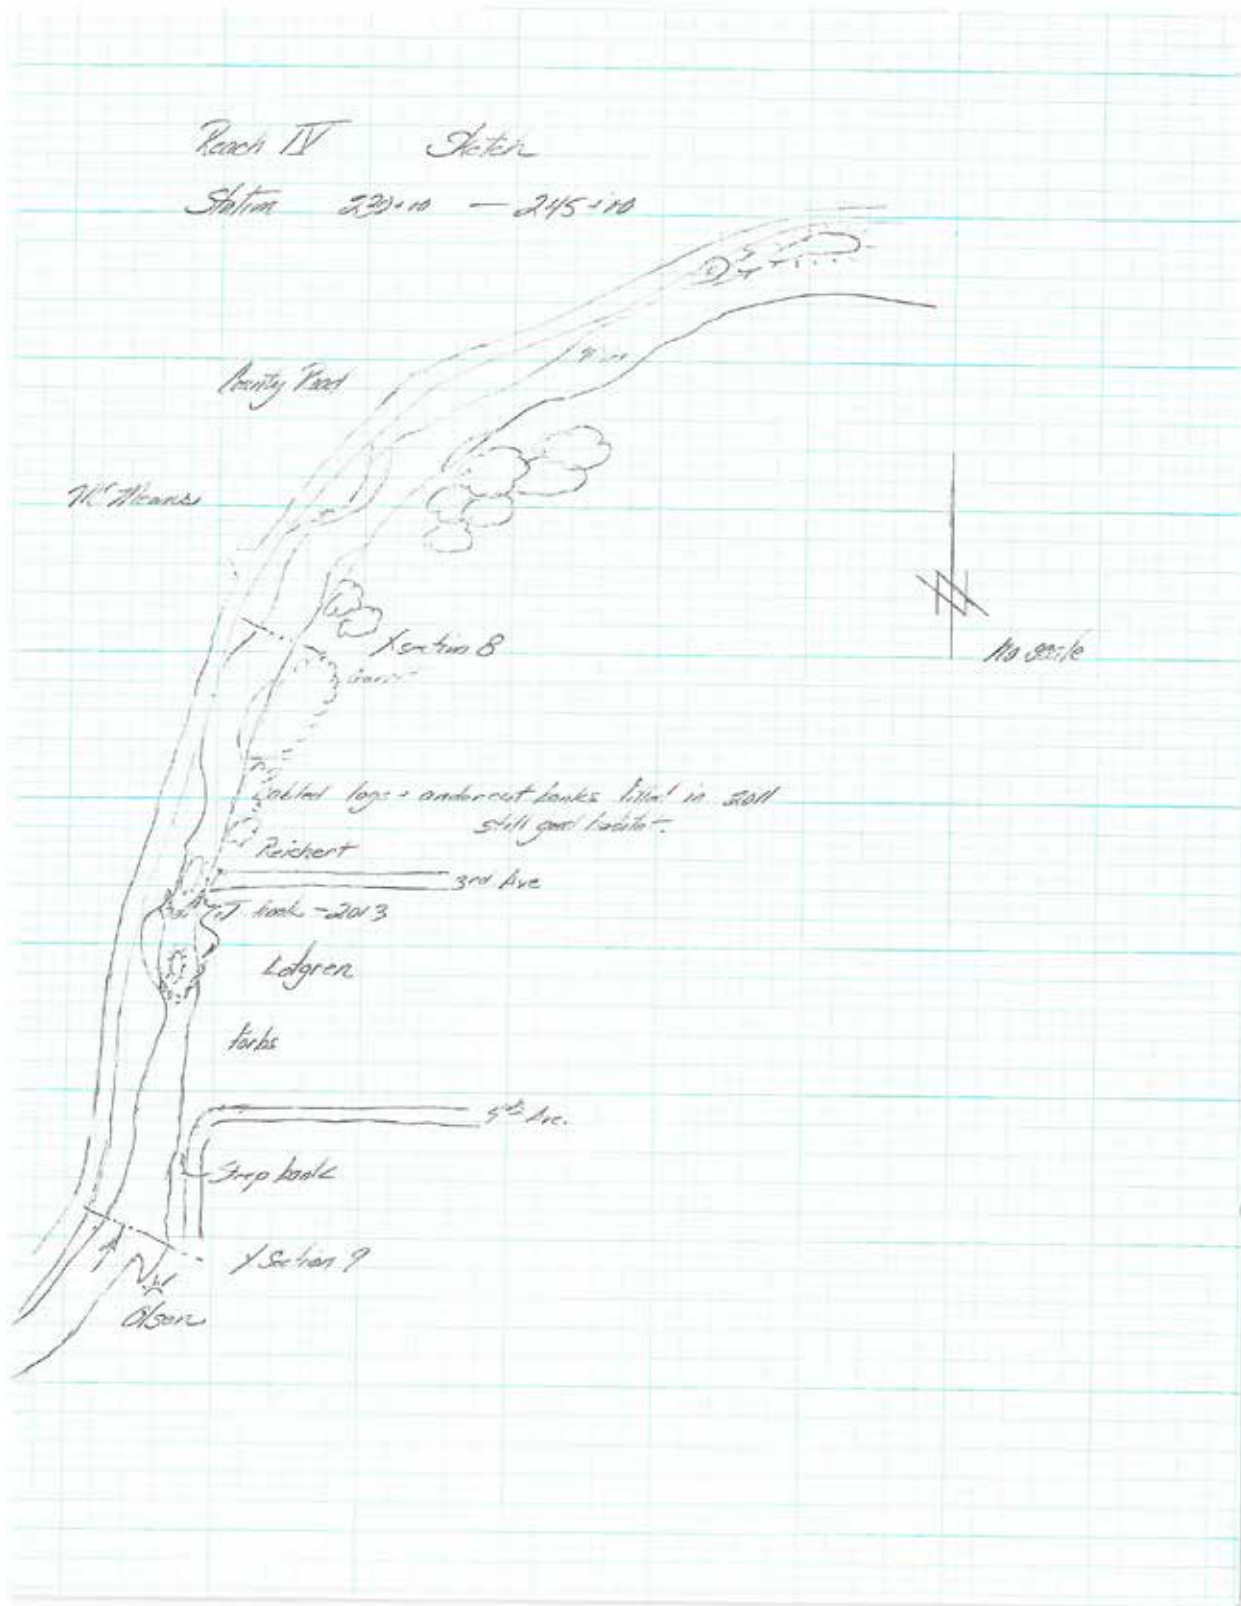
Site Diagram

- Element 4: Riparian Area Quantity. The River is incised through this reach: 600 linear ft. x 180 ft. for the lower reach on the right side. The upper half of the right side has gaps in native vegetation which is mostly replaced by lawns. The left side is native but its width is reduced by the Tongue River road.
- Element 5: Riparian Area Quality. The native wetland vegetation has been replaced in many areas of this reach with sod forming grasses for lawns.
- Element 6: The Canopy Cover lacks the shrub element and overhanging vegetation.

4. Define intermediate berm during low water periods and use the meander pattern in place to enhance that observed pattern. Need to incorporate woody vegetation in this effort.

5. Plant shrubs along bank to provide shade to waterway.
6. Install practices to reduce urban input of sediment and nutrients to stream.

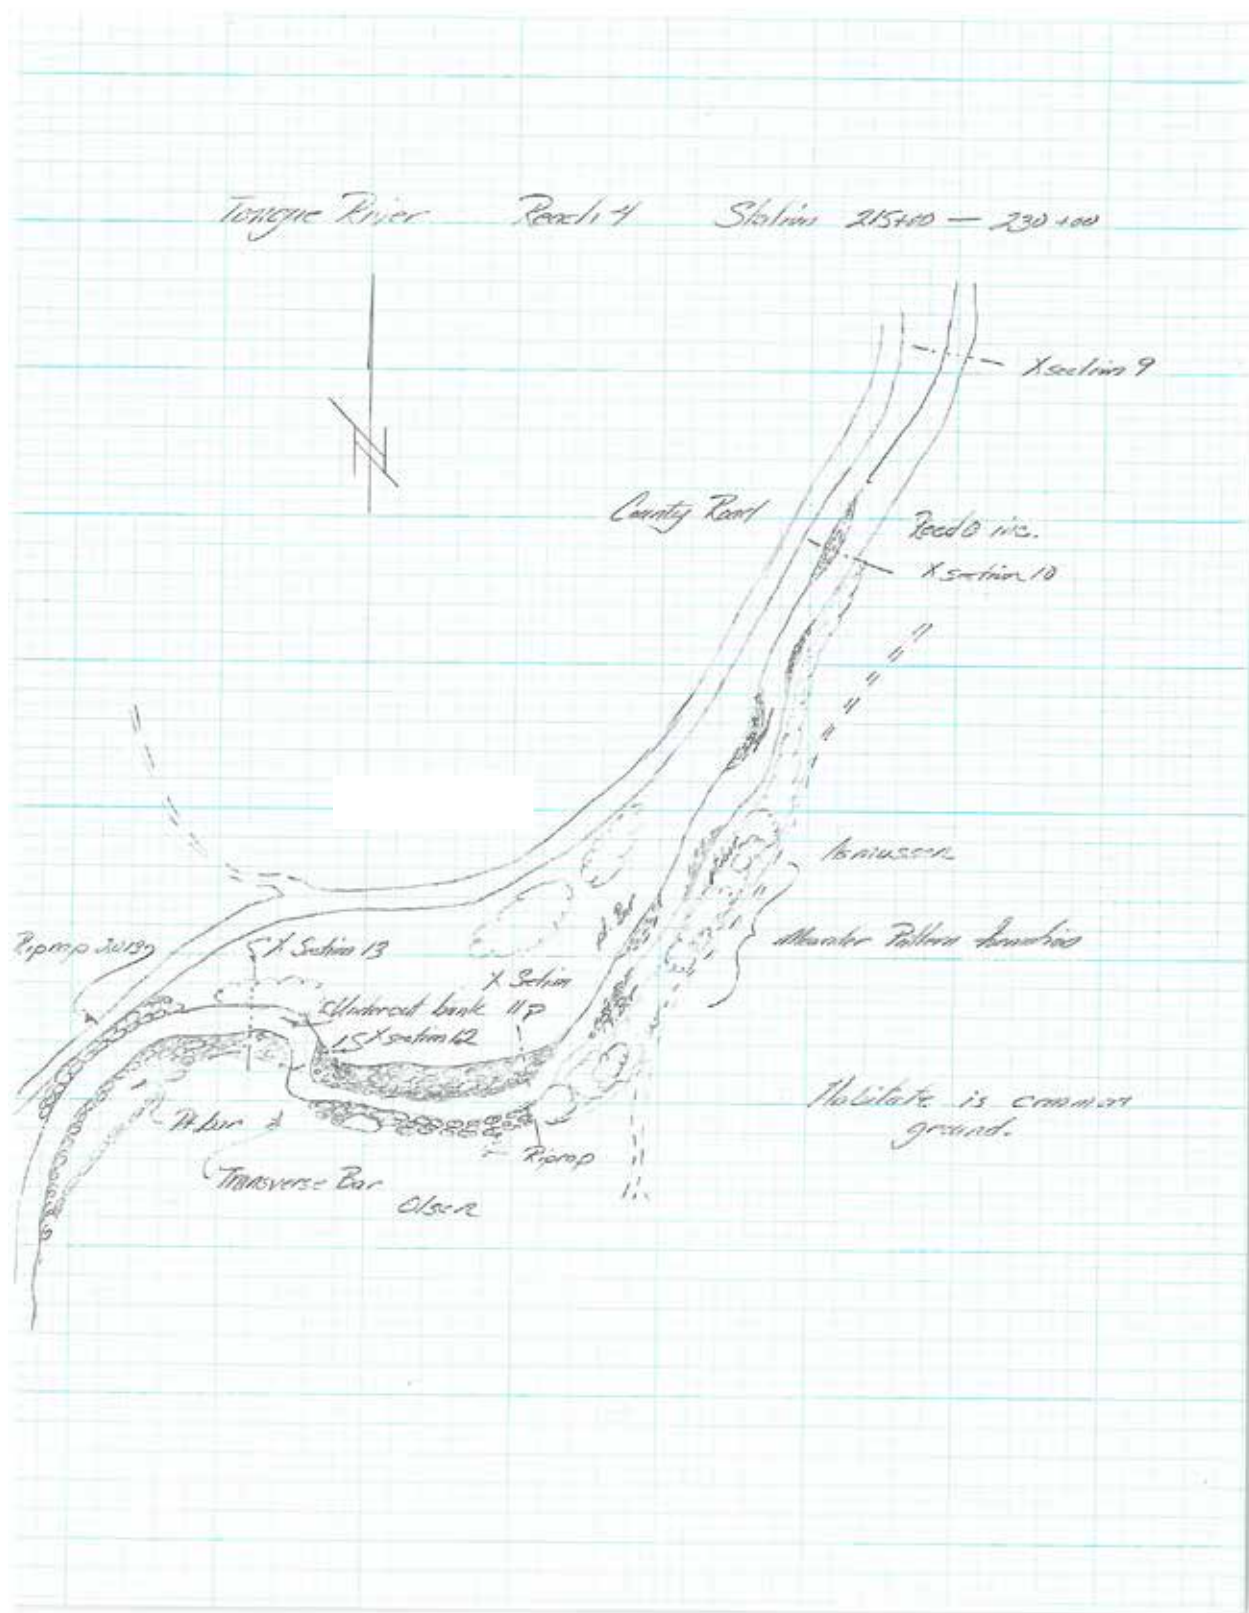
Site Diagram

- Element 1: Channel Condition: Head cut moving upstream between cross sections 15 and 16 near county road. It looks to be in channel evolution stage II or III. Annual plants growing on point bars. Extensive riprap along both sides from 220+00 to 225+00. One willow holding bank together and providing a deep pool.
- Element 4: Riparian Area Quantity. Active bank erosion has removed many of the woody elements through this reach which also affects the canopy cover. The lack of woody vegetation could be a result of fire in 2003.
- Element 5: Riparian Area Quality. The native wetland vegetation has been left high and dry by river down cutting through the head cut. Weeds growing on point bars.
- Element 6: The Canopy Cover is less than 20% for the entire reach again due to fire. It also lacks the shrub element; there is little or no overhanging vegetation in much of this reach.

- Landowners may use structures downstream as a blueprint for future work on this reach.
- There is a general lack of woody material in this reach. Consider pine tree revetment, root wade installations or toe wood installations which add structure to channel at strategic locations to create riffle/pool complexes.
- Define intermediate berm during low water periods and use the meander pattern in place to enhance pattern.
- Plant shrubs along bank to provide shade to waterway.
